Gila River Indian Community Utility Authority Report Concerning Storm 1 - July 9, 2021 And Storm 2 - July 10, 2021

August 19, 2021

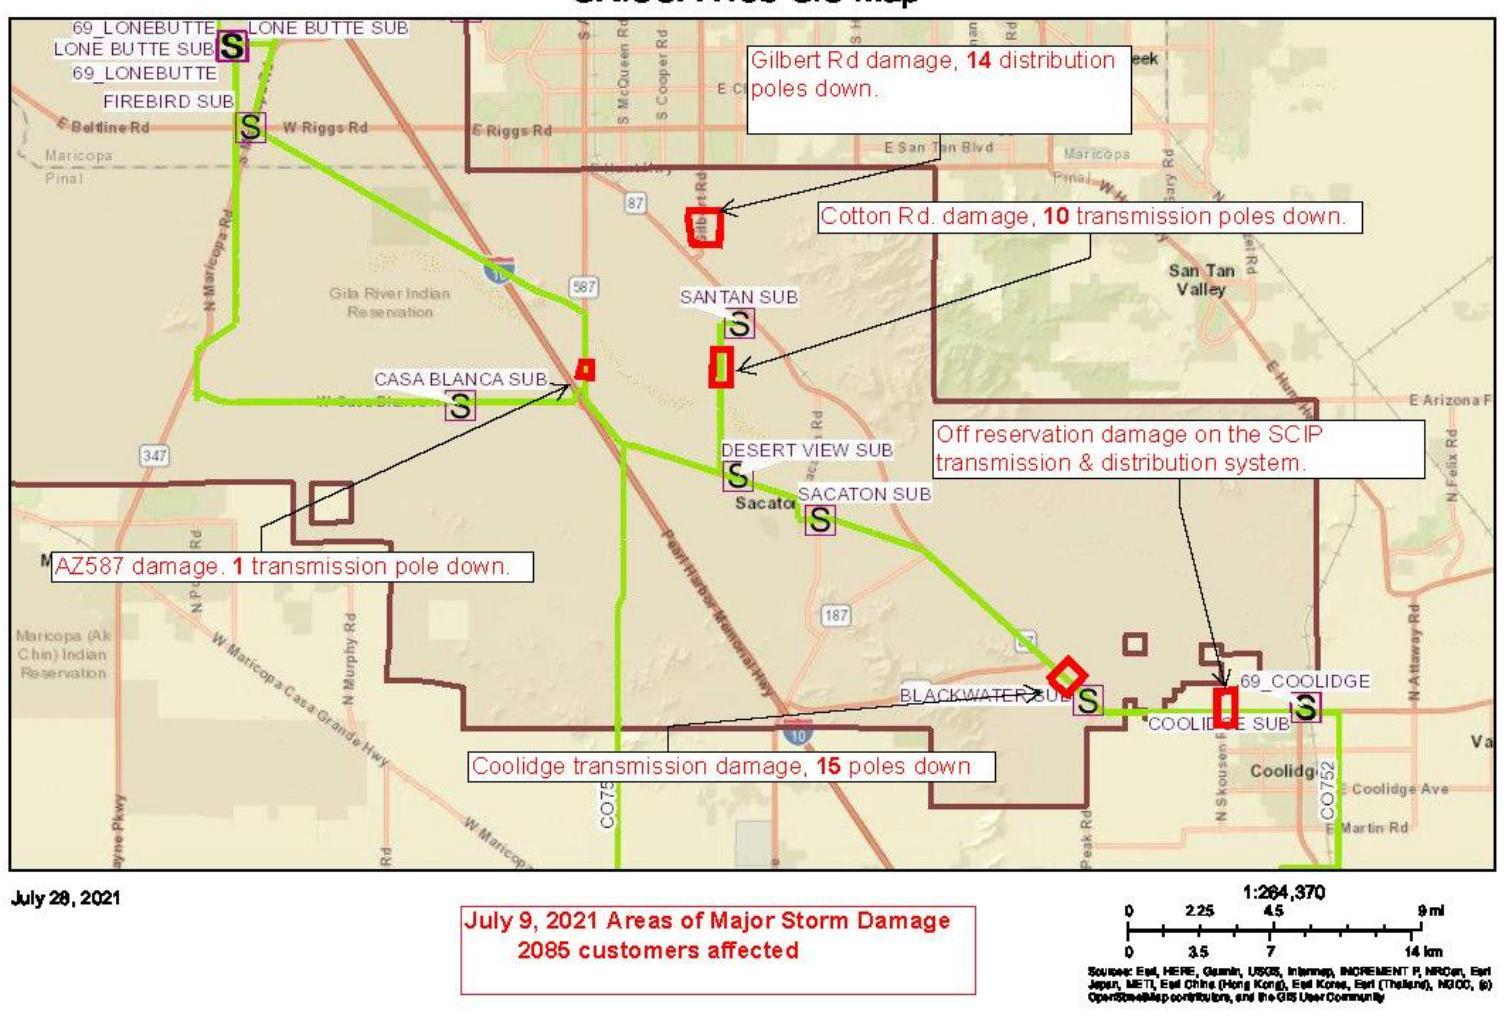
Diagram 1 on the next page shows 5 locations of the most severe damage where poles and wires were down. Following Diagram 1 are pictures of some of the damaged infrastructure.

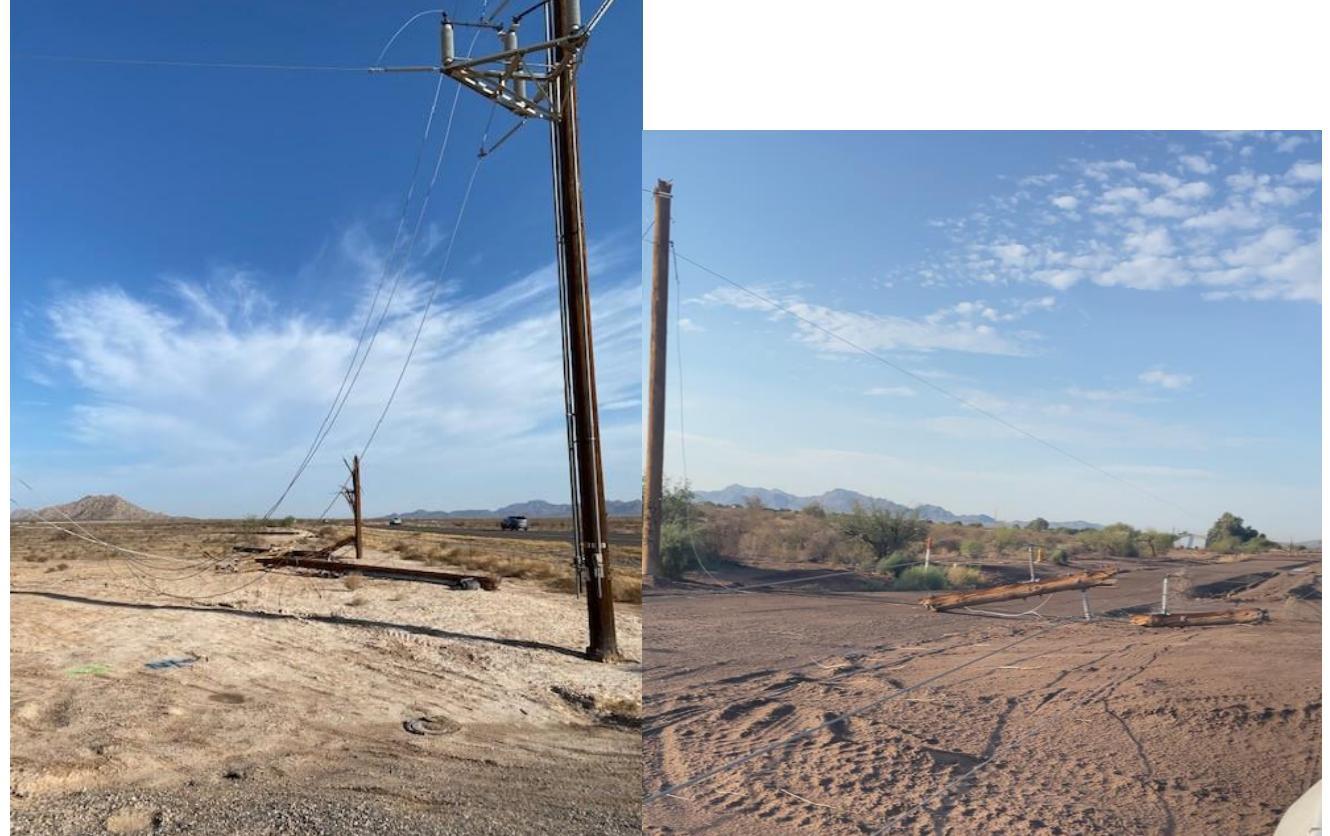
Coolidge 69 kV Damage – 15 poles down Cotton Road 69 kV Damage – 10 poles down

- 15 transmission poles with 12kV under-build down on the Coolidge transmission line north of Blackwater Substation along Hwy 87.
- 10 transmission poles with 12kV under-build down along Cotton Rd. on the Santan transmission line, taking the Santan Substation out of service.
- 1 transmission pole with 12kV under-build down on AZ587 on the Casa Blanca transmission line.
- 14 12kV poles down along Gilbert Rd.
- Transmission line with 12kV under-build damage off reservation near Coolidge caused an outage in the Blackwater area of D1.
- Additional, spot damage in Districts 1-5.
- 2,085 customers affected.
- Outage notification provided to Community leaders.

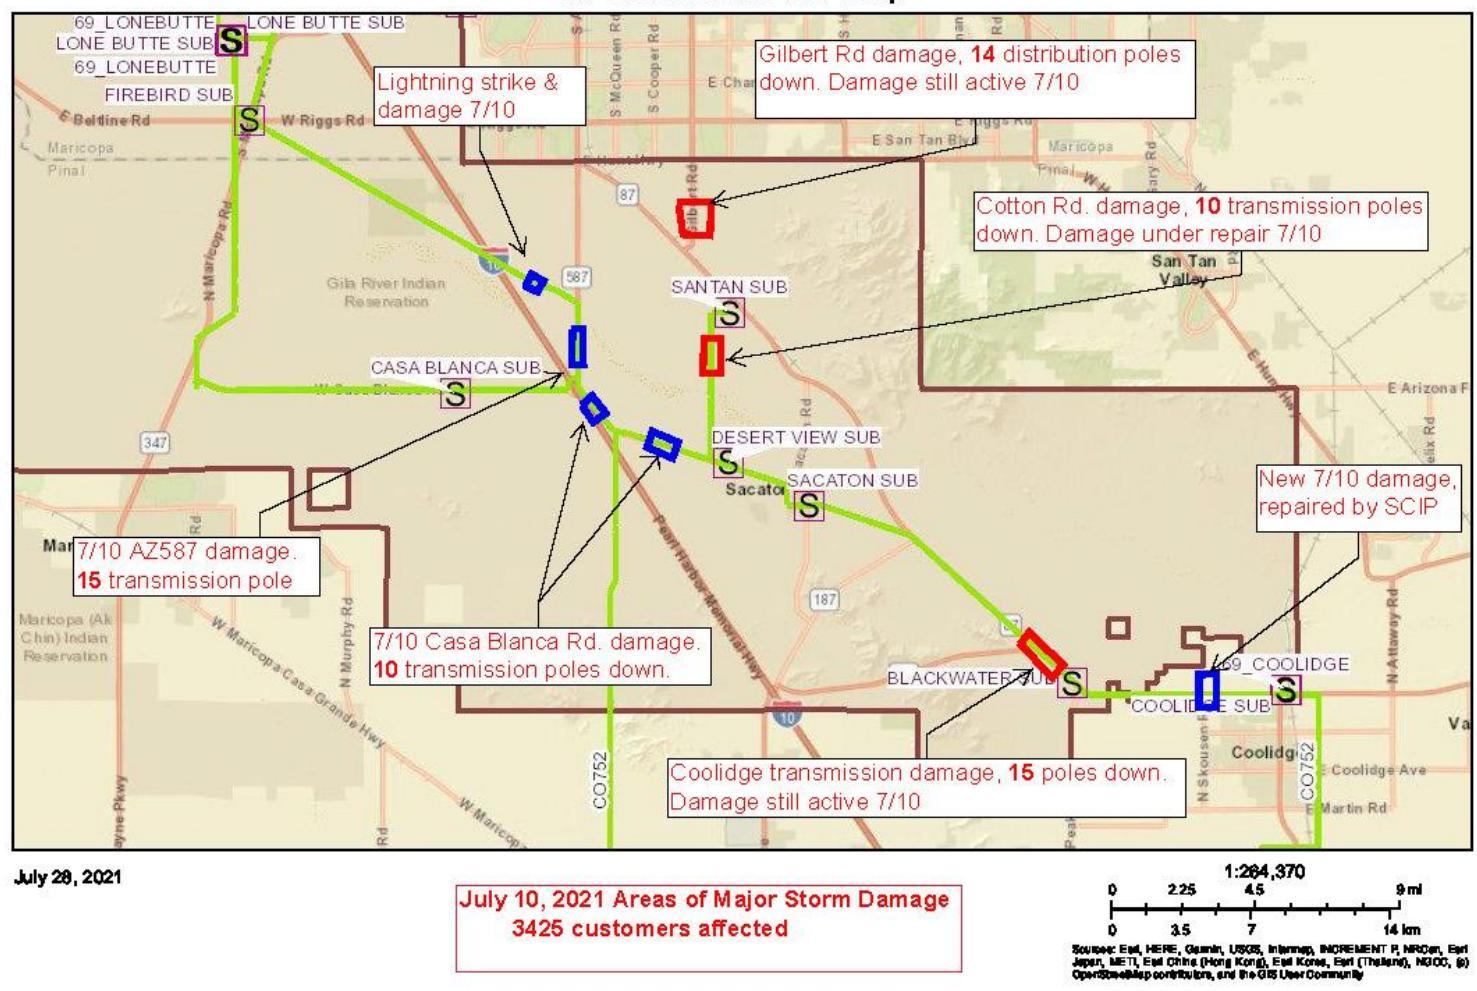
Diagram 2 on the next page shows 4 additional locations of the most severe damage where poles and wires were down in addition to the remaining 3 out of 5 locations from the Storm 1 - July 9. Following Diagram 2 are pictures of some of the damaged infrastructure.

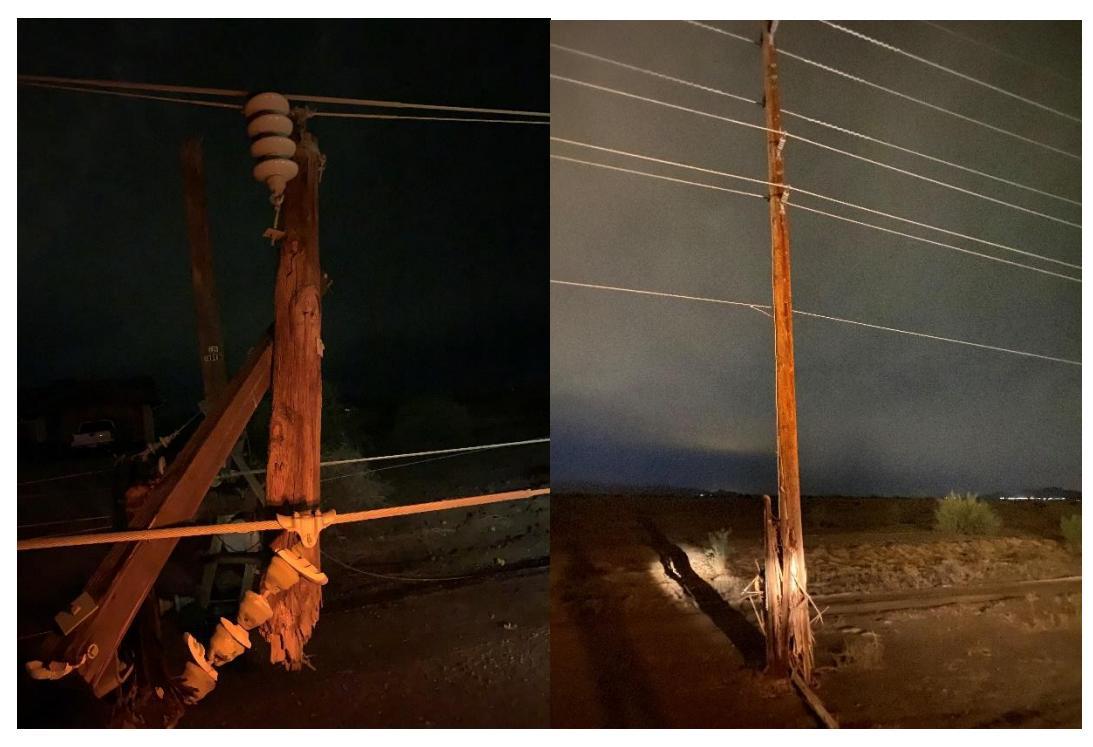
AZ587 Damage

Pole installed in 2020 on Casa Blanca Rd

- 15 transmission poles down along SR-587 trapping some Community members in their homes and motorists in their cars.
- Off reservation, damage caused widespread outages in District 1.
- 10 transmission poles with 12 kV under-build were down on the Casa Blanca transmission feed to Desert View and Sacaton Substations. This resulted in extended outages in District 2 & 3 and part of District 4.
- Outage notification is provided to Community leaders.

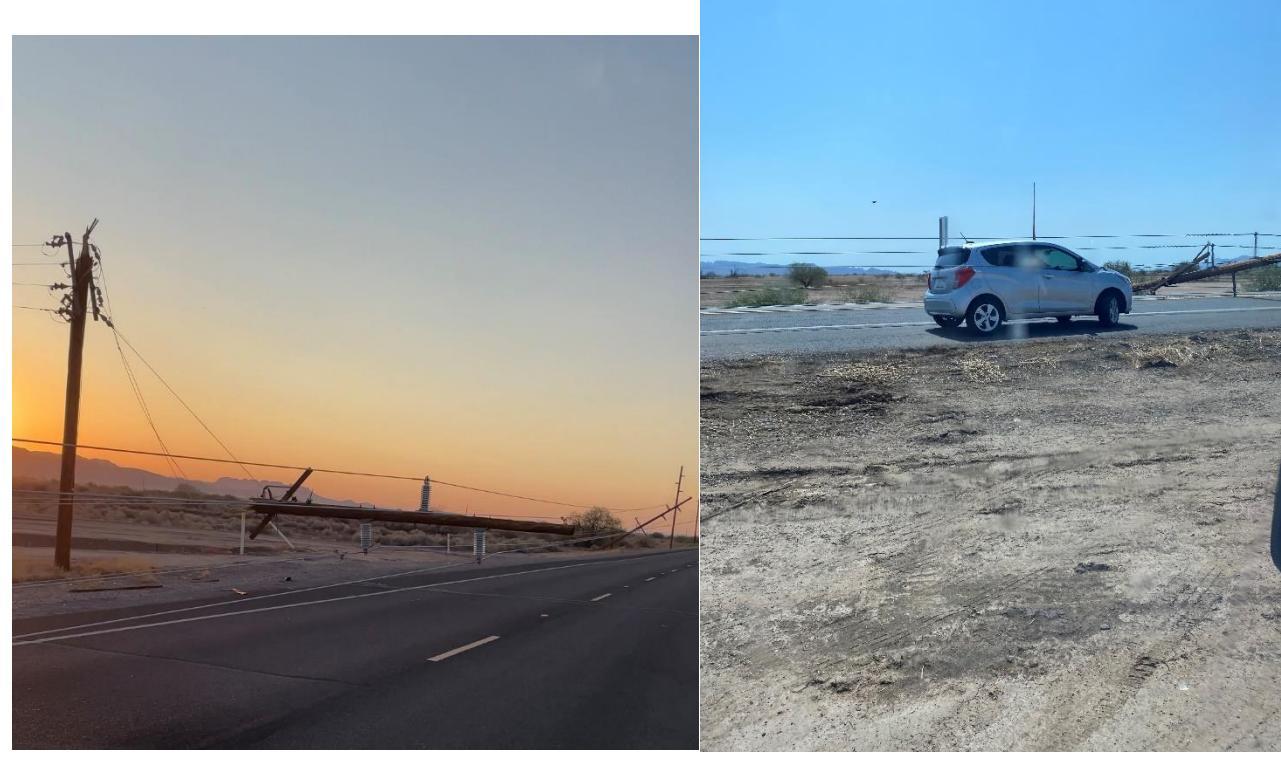
Casa Blanca Rd

Car trapped on AZ587

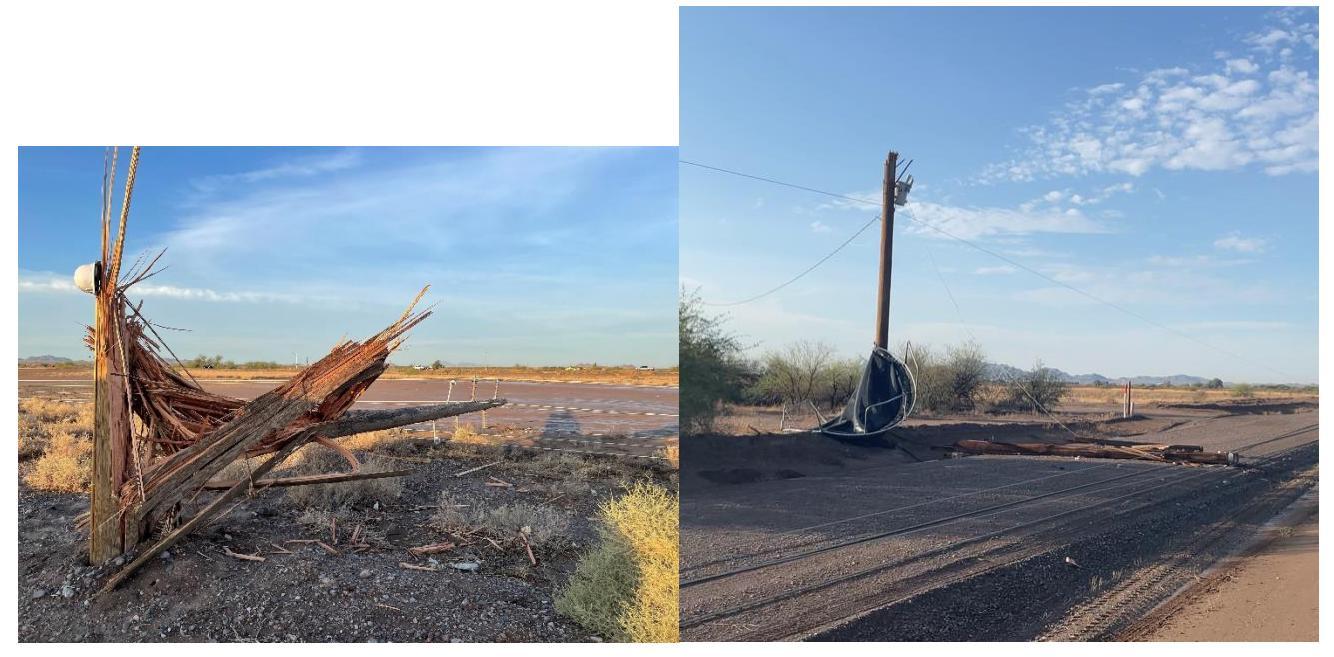
Newer pole on AZ587

Wind broke top of pole on AZ587

Transmission poles have a life expectancy of up to 60 years. Some of the poles that were broken during the storm were in the 20 - 30 year range and some had been installed in the last 12 to 36 months. The GRICUA crews that were supervising the restoration noted that the majority of the damaged poles were in acceptable condition. However, they did notice that there were several poles that had termites. In addition, they also reported that most of the poles broke 10 to 15 feet above the ground, which indicates that the bases of the poles were solid and that high winds caused initial damage.

Yes, all materials and work quality met the same specifications and standards as required for all of its projects. GRICUA crews supervised contractors to make sure that both safety and standards were met. All of the material used in the restoration process was GRICUA approved material and came directly from our inventory or vendors that provide material per the GRICUA material specifications. The repairs included "Stopper Pole" installation every 4<sup>th</sup> pole.

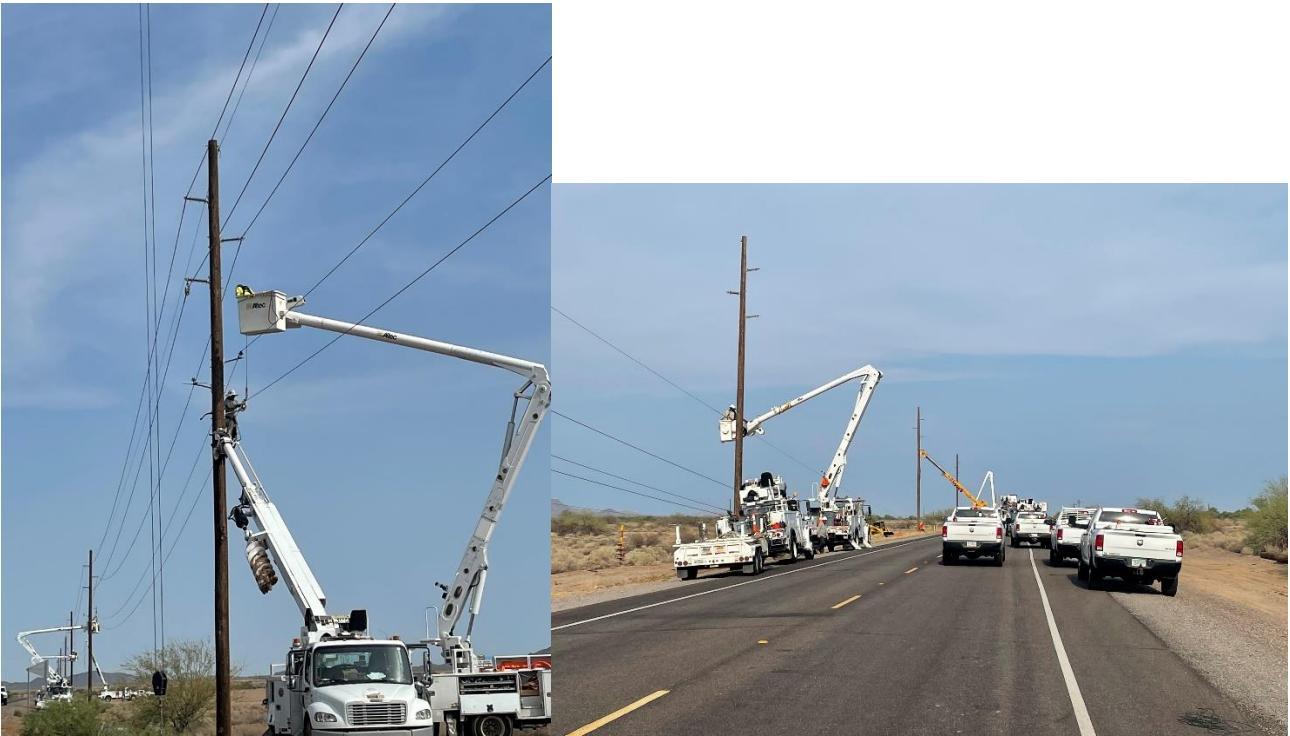
Rebuilding on Casa Blanca Rd.

- <u>6:00 AM to Midnight 7/11/2021</u>
  - ✓ Five crews are assigned to the top priority Casa Blanca Rd transmission line repair.
  - ✓ Repair is complete at 9:00 PM 7/11/2021.

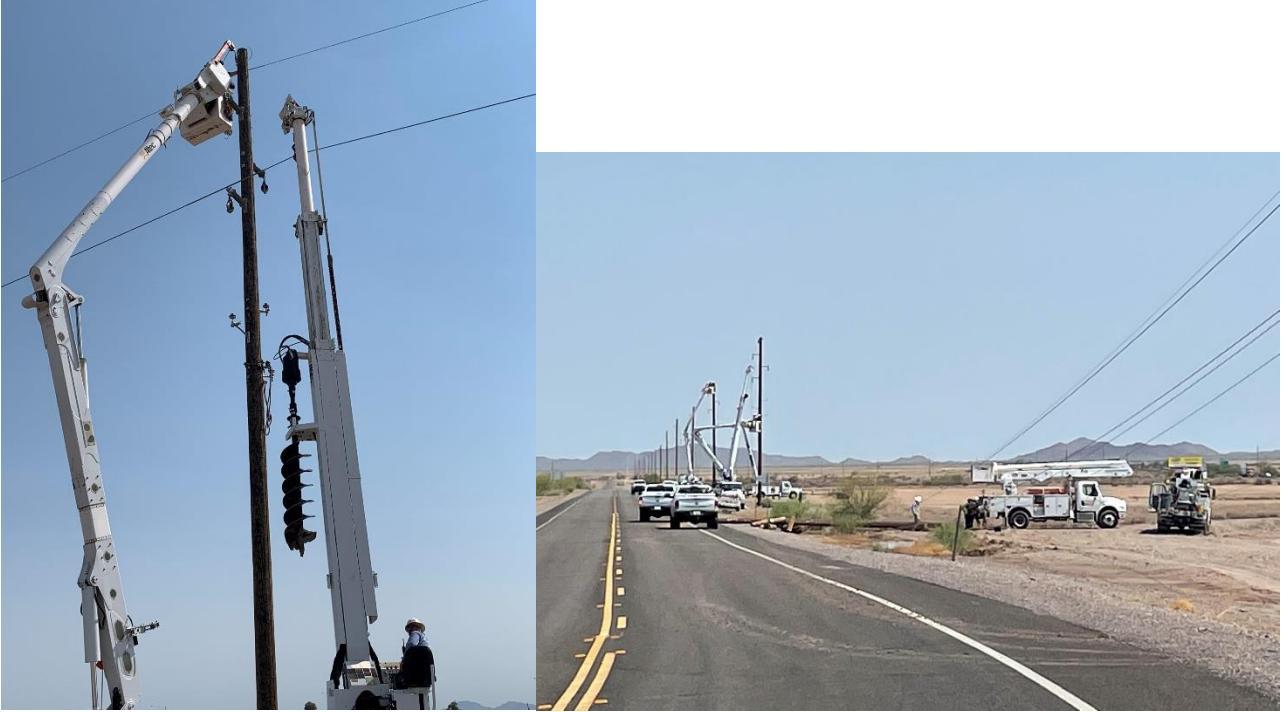
Re-setting poles on AZ587
