Gila River Indian Community Utility Authority Report Concerning Storm 1 - July 9, 2021 And Storm 2 - July 10, 2021

August 19, 2021

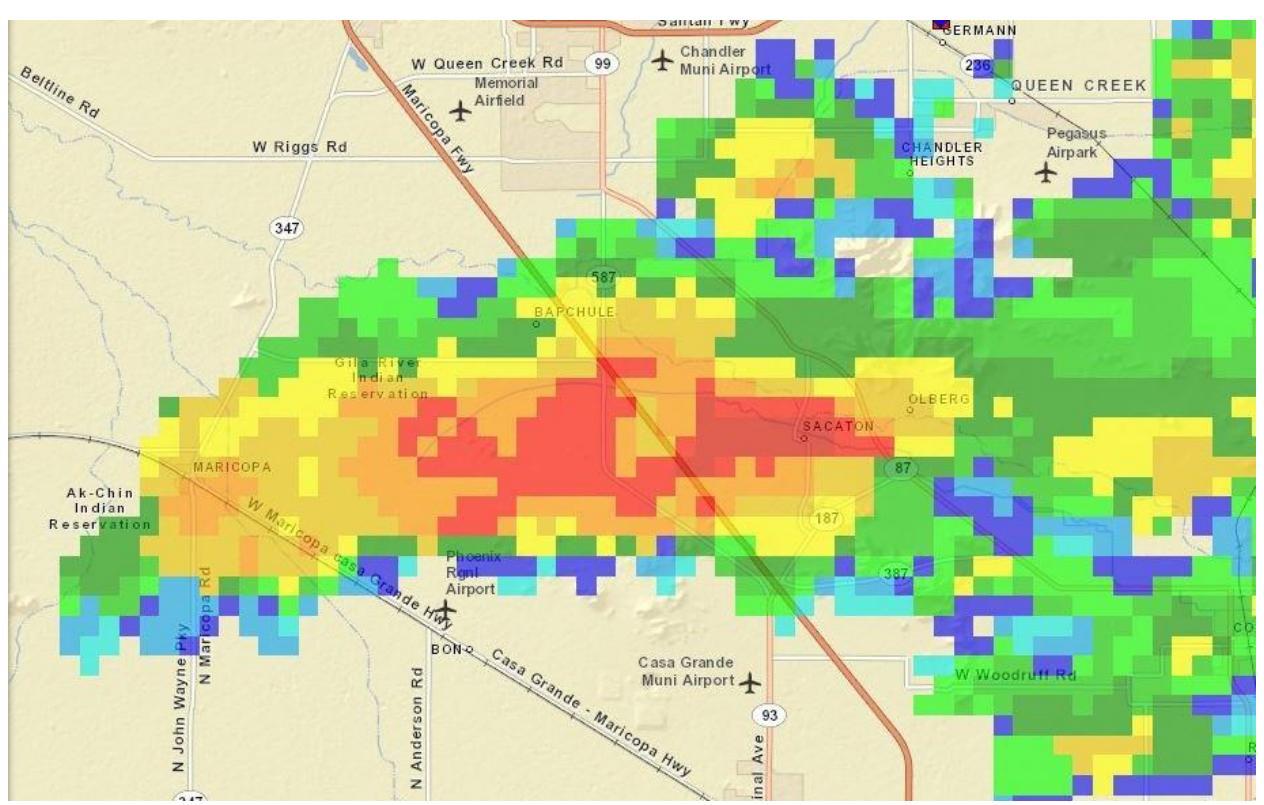
## Screenshot 1 Screen shot of weather radar 7/9/21 @ 10:00 PM

At approximately 9:50 PM Storm 1 – July 9, a major monsoon storm, struck the Community from the northeast with microbursts, blowing dust, severe winds, and heavy rains. Storm 1 - July 9 affected Districts 1-4, and the east end of District 5. Screenshot 1 below provides a picture of the weather radar map at 10:00 PM.

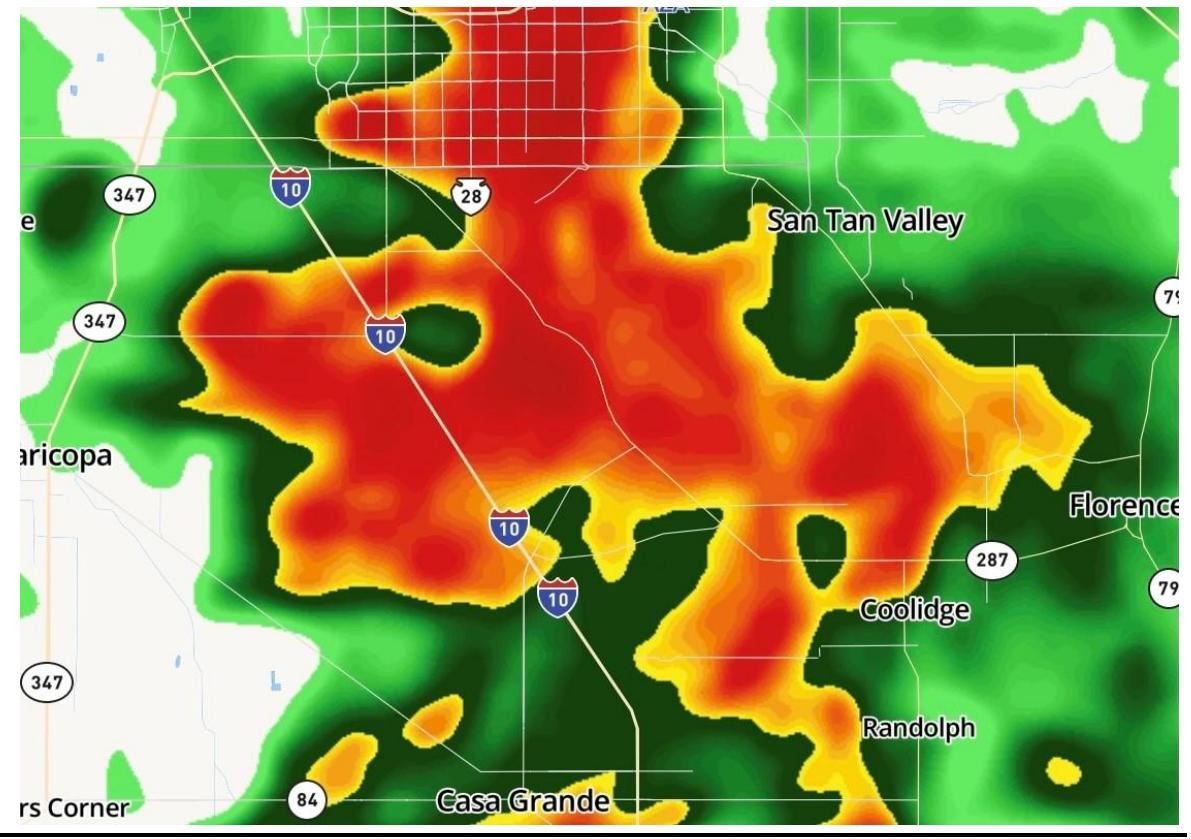
Screenshot 2 Screenshot of weather radar @ 7/10/21 8:00 PM

Less than 1 hour after GRICUA had restored service to 90% of its customers and less than 24 hours since Storm 1 - July 9 had hit the Community, a second major monsoon storm hit the Community. Storm 2 - July 10 was more widespread and more severe than Storm 1 - July 9 and caused additional damage to the GRICUA transmission and distribution systems. 3,425 customers were affected. Screenshot 2 below provides a picture of the weather radar map at 8:00 PM.

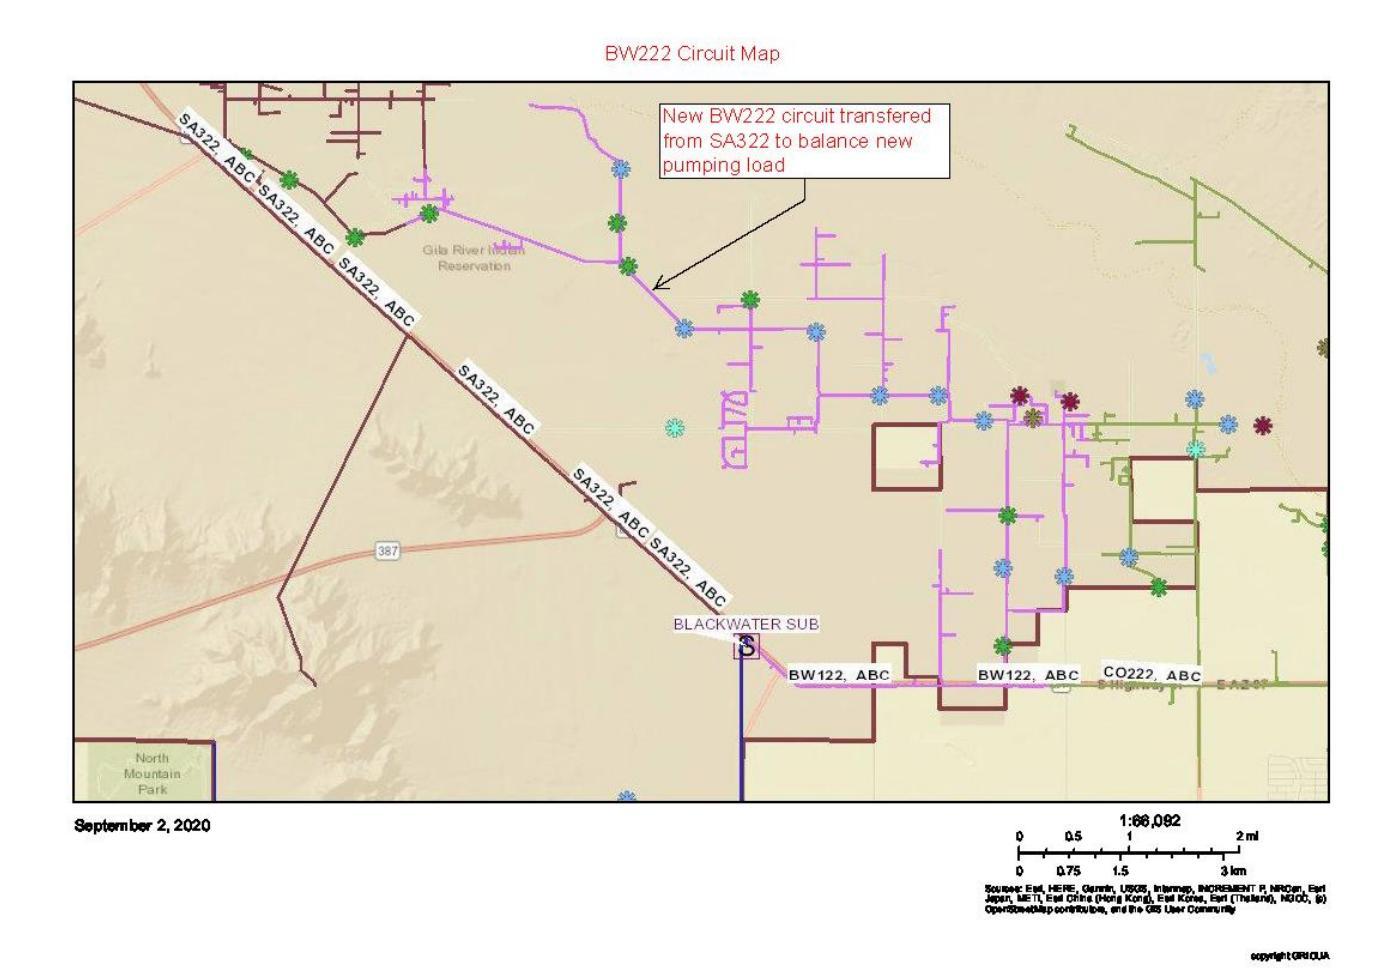
- The structured system line patrol includes visual inspection of line condition and the condition of the associated poles, cross arms and hardware. The 2019 inspection and circuit loading evaluation process helped identify circuits that are subject to voltage drop during high demand summer months. The inspection report and evaluation were used to justify the installation of capacitor banks in 2019 to improve line voltage. There have been no broken line outages that were unrelated to major storms since 2013, but inspections did identify areas of concern that were scheduled for line upgrade work in 2020. One of those concerns was voltage drop on the SA322 circuit cause by the installation of GRIIDD irrigation facilities. The Blackwater substation upgrade and addition of the BW222 circuit was the result of this evaluation. GRICUA

also evaluates line fuse sizing following outages related to blown line fuses. Fuse information is entered into the GIS data and used to evaluate coordination to better protect the distribution system. See BW222 circuit map below.

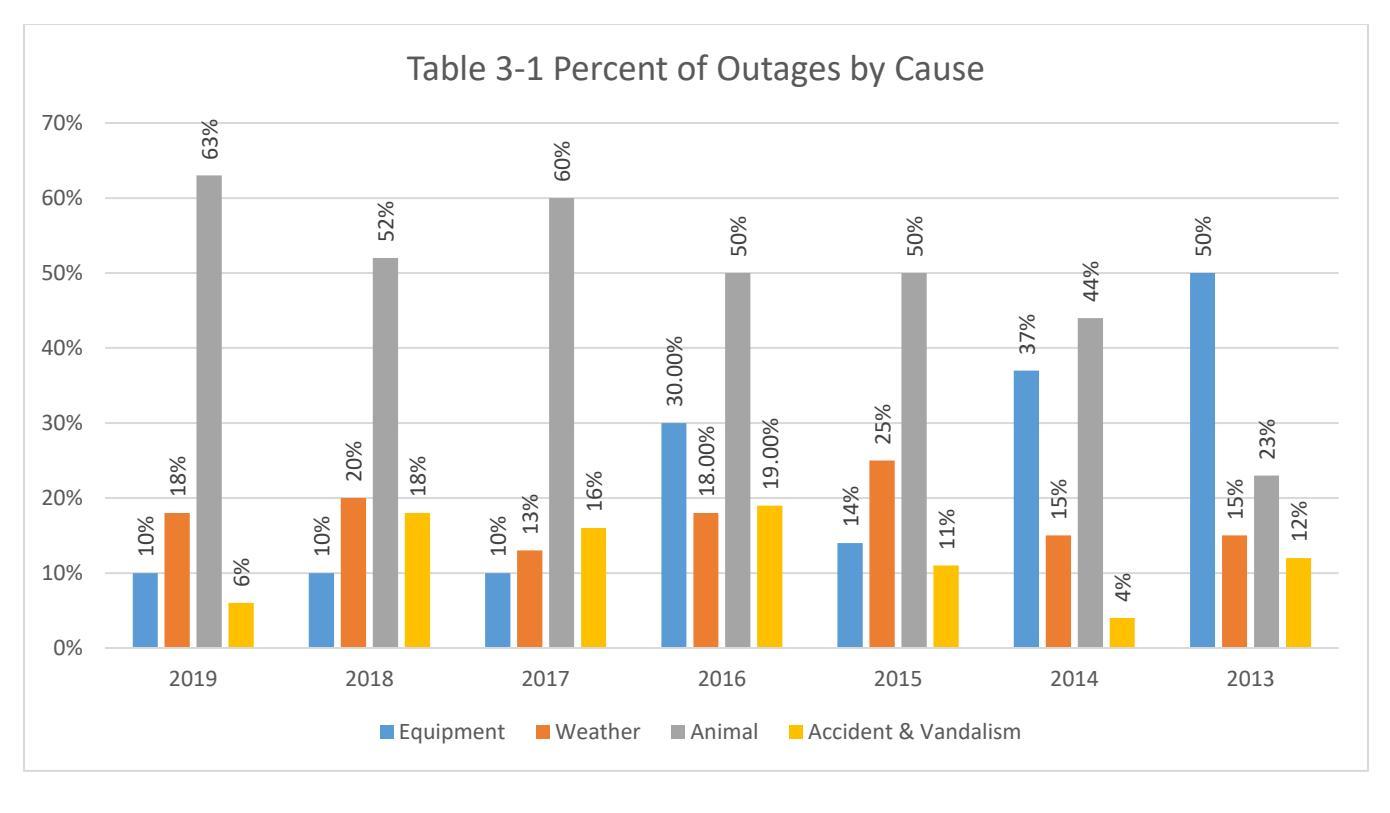
Table 3-1 illustrates outages causes in 2013 thru 2019. Equipment related outages decreased measurably in 2017 and 2018. Animal related outages decreased in 2018 following a more aggressive avian protecting effort. The GRICUA purchasing and technical staff continues to research and identified new products developed to prevent birds from contacting energized line components and incorporate approved products into the GRICUA inventory.
